ADDENDUM No. 2
December 1, 2023

Columbia Lake Dam: Slide Gate Assembly Rehabilitation
Columbia, Connecticut

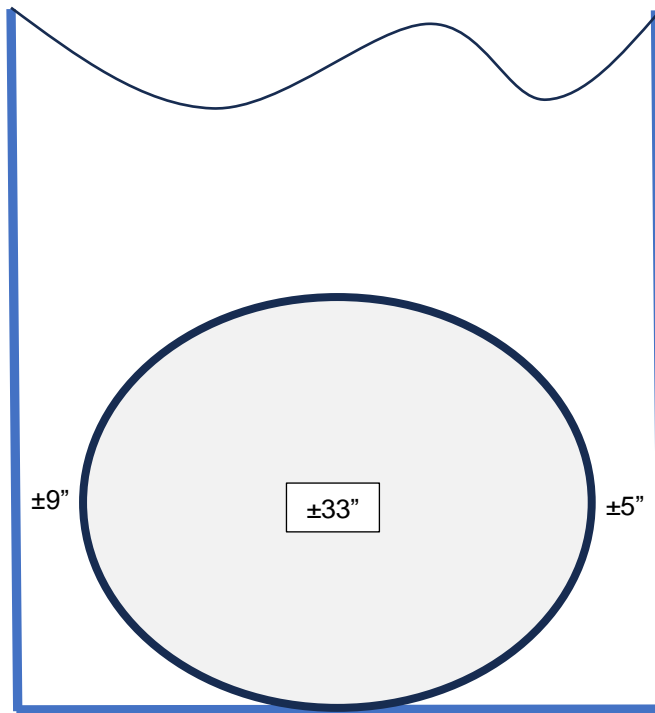
1. Flow restriction to the gate vault will have to be done at the interior of the vault. The inlet structure prevents safe means of sealing the intake pipe.

2. The inlet pipe invert is flush to the invert of the valve vault.
3. The siphon pipe for the fire supply system conflicts with work at the inlet pipe. Bids shall include removal and disposal of the intake pipe and replacement in kind at the completion of the gate repair.

30-inch concrete inlet pipe on skew. Zero bottom clearance. Vault interior width ± 48 -inch.
