Tuesday, November 21, 2023
Columbia Lake Dam
Gate Valve Inspection &
Intake Inspection

On 11/21/2023, Shoreline Diving and a 3-man dive team inspected the gate valve and intake at Columbia Lake Dam off RT87 in Columbia, CT. Gate valve is SN-06651-2 was ordered approximately around 08/05/1980 from Rodney Hunt. The sluice gate valve is 24x24 with an S-2600 operator.

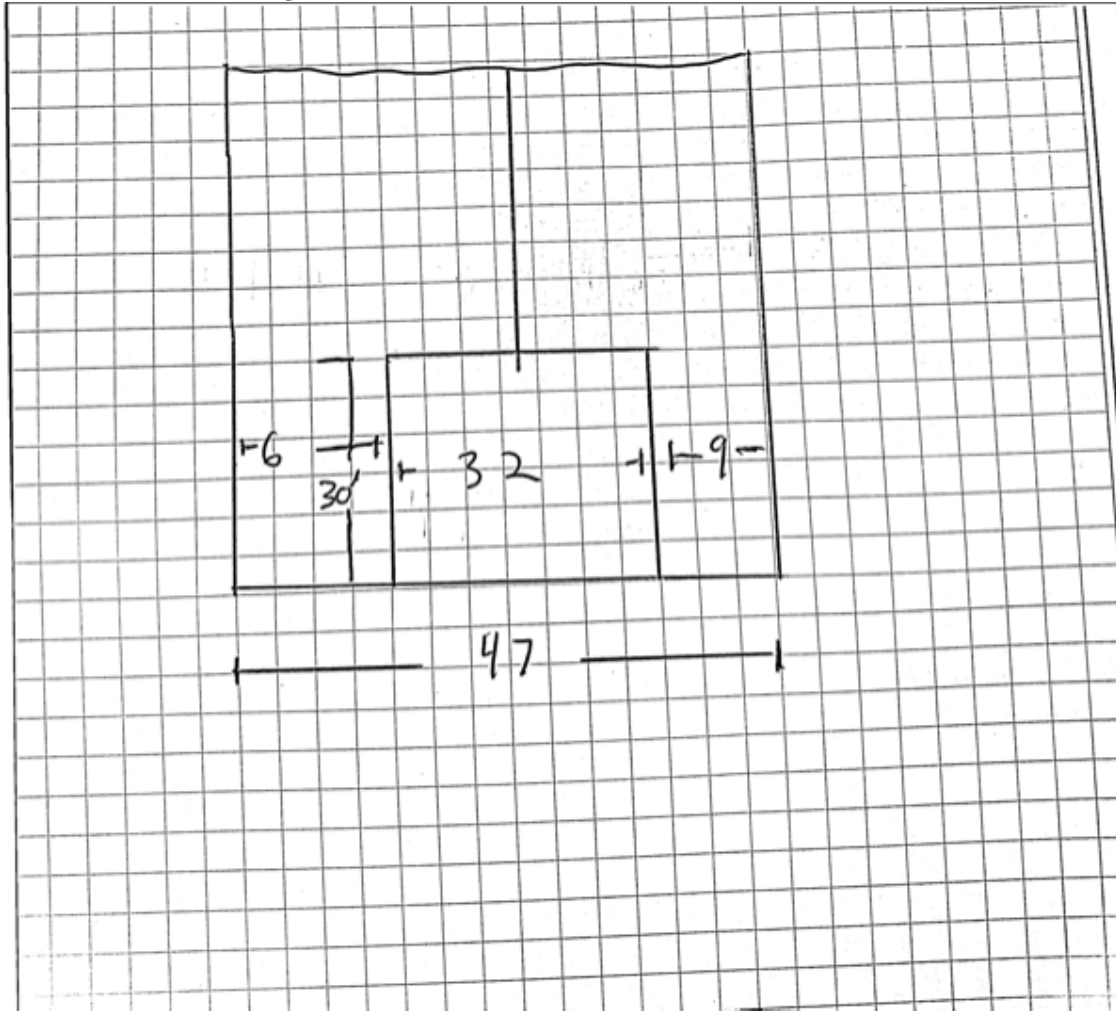
Sluice gate measurements

The gate valve has some tubercular growth and should be cleaned. The wedges and guides appear to be in good working order. Shoreline was not able to inspect the face seal but the valve appears to have normal seepage for a valve of this age and over all the valve is in fair condition for its age.

Our recommendations are as follows. Clean and repack the valve operator. The second recommendation would be to clean the valve and adjust the wedges, to see if any more seepage could be stopped (right now the valve has normal seepage). Finally, we would recommend installing a weir board system to help control the water level.

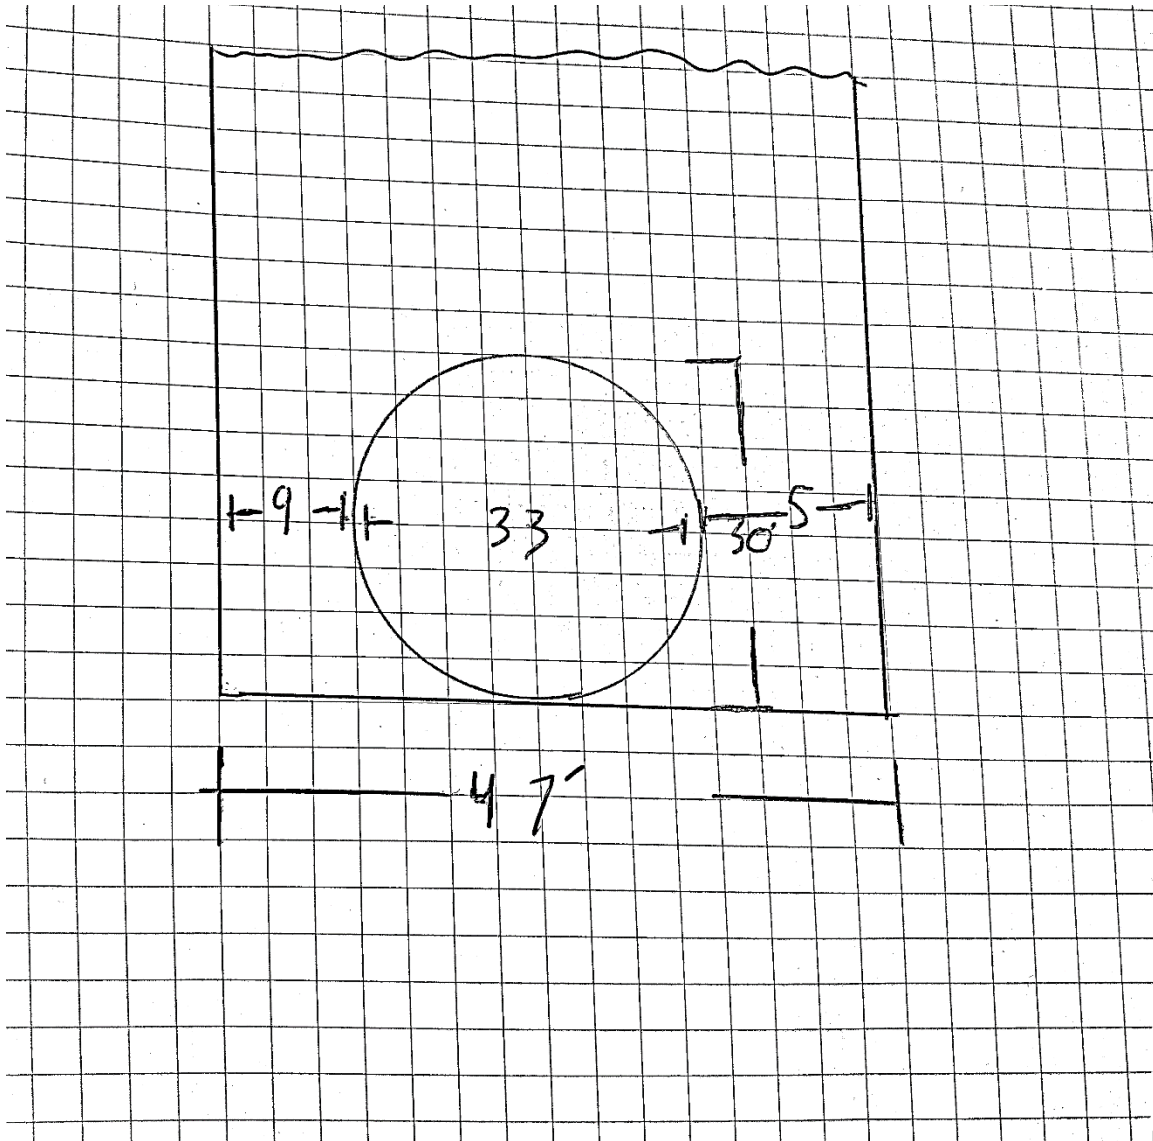
30 inch intake pipe measurements

The intake structure is composed of 3 precast concrete boxes approximately 48x45x45. The intake boxes are in a straight line and just stacked next to one another with the 30-inch intake pipe stuck into the end of the first box covered by riprap rock.
