Tuesday, November 21, 2023
Columbia Lake Dam
Gate Valve Inspection &
Intake Inspection

On 11/21/2023, Shoreline Diving and a 3-man dive team inspected the gate valve and intake at Columbia Lake Dam off RT87 in Columbia, CT. Gate valve is SN-06651-2 was ordered approximately around 08/05/1980 from Rodney Hunt. The sluice gate valve is 24x24 with an S-2600 operator.

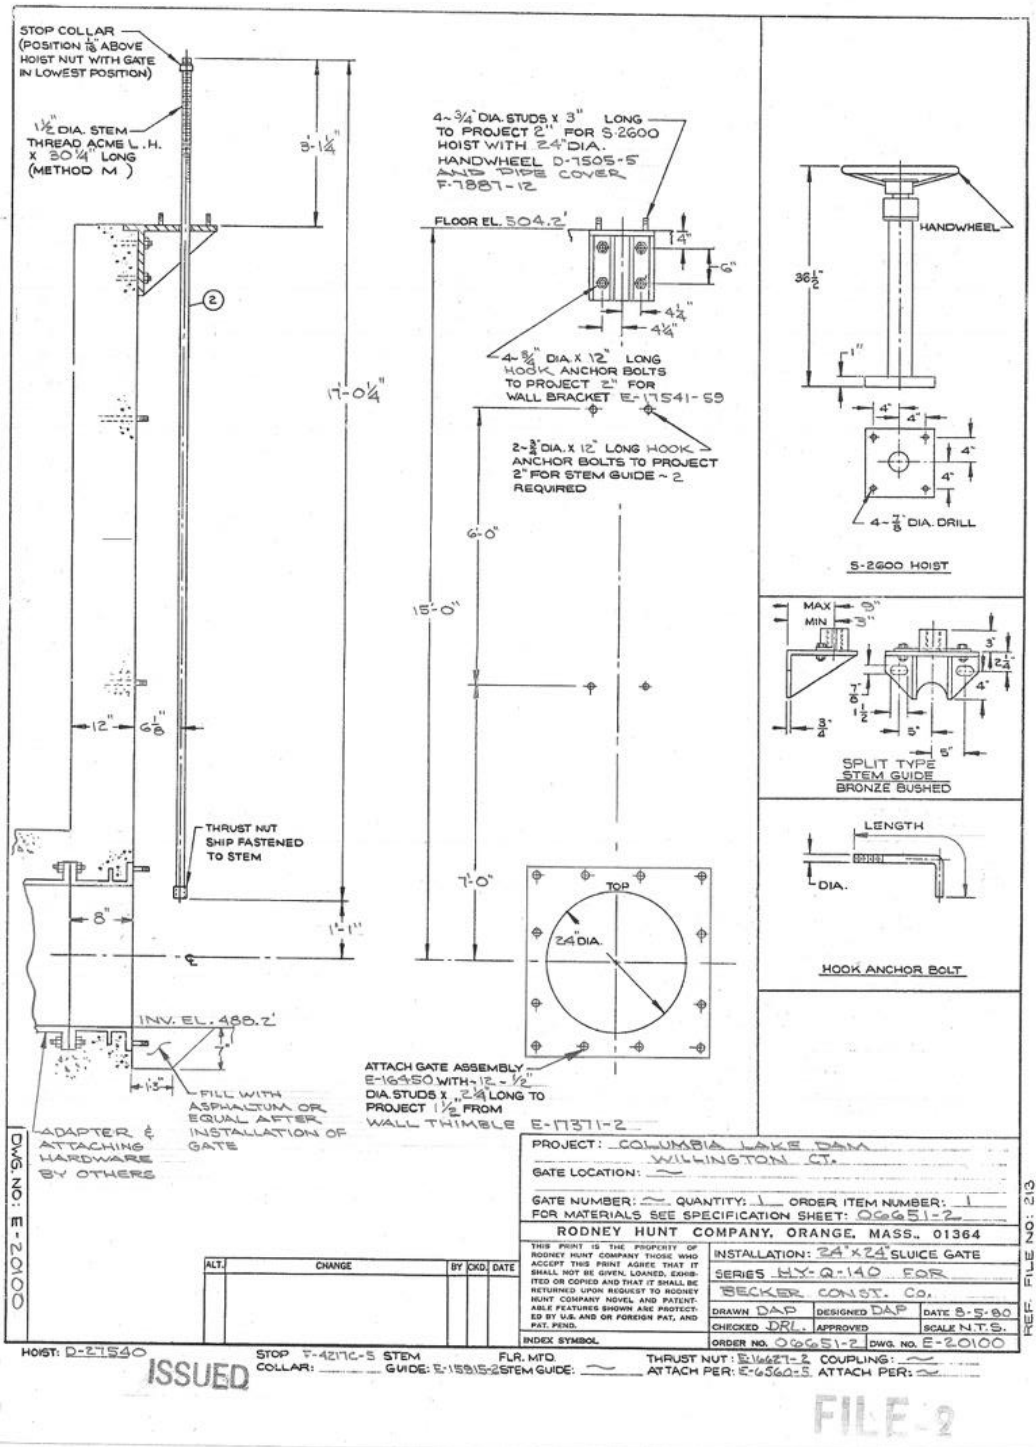
The gate valve has some tubercular growth and should be cleaned. The wedges and guides appear to be in good working order. Shoreline was not able to inspect the face seal but the valve appears to have normal seepage for a valve of this age and over all the valve is in fair condition for its age.

Our recommendations are as follows. Clean and repack the valve operator. The second recommendation would be to clean the valve and adjust the wedges, to see if any more seepage could be stopped (right now the valve has normal seepage). Finally, we would recommend installing a weir board system to help control the water level.
